New York State Department of Transportation

Yellow Flag NB2222W016

Structure Information

Gowanus Expressway
2022 Biennial Inspection – Field Notes

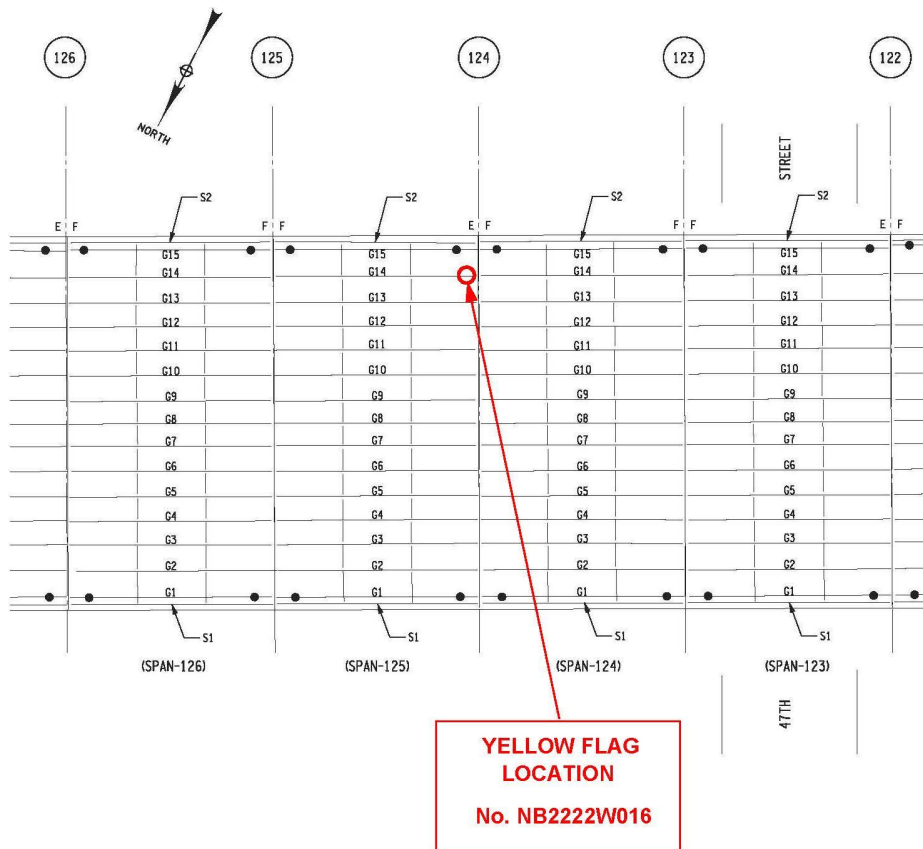
Flag PhotographsPhoto Number: **1**Photo Filename: **BIN1065318 YF NB2222W016 Framing Plan - SN125**

Attachment Description: General view of framing plan with defect location.

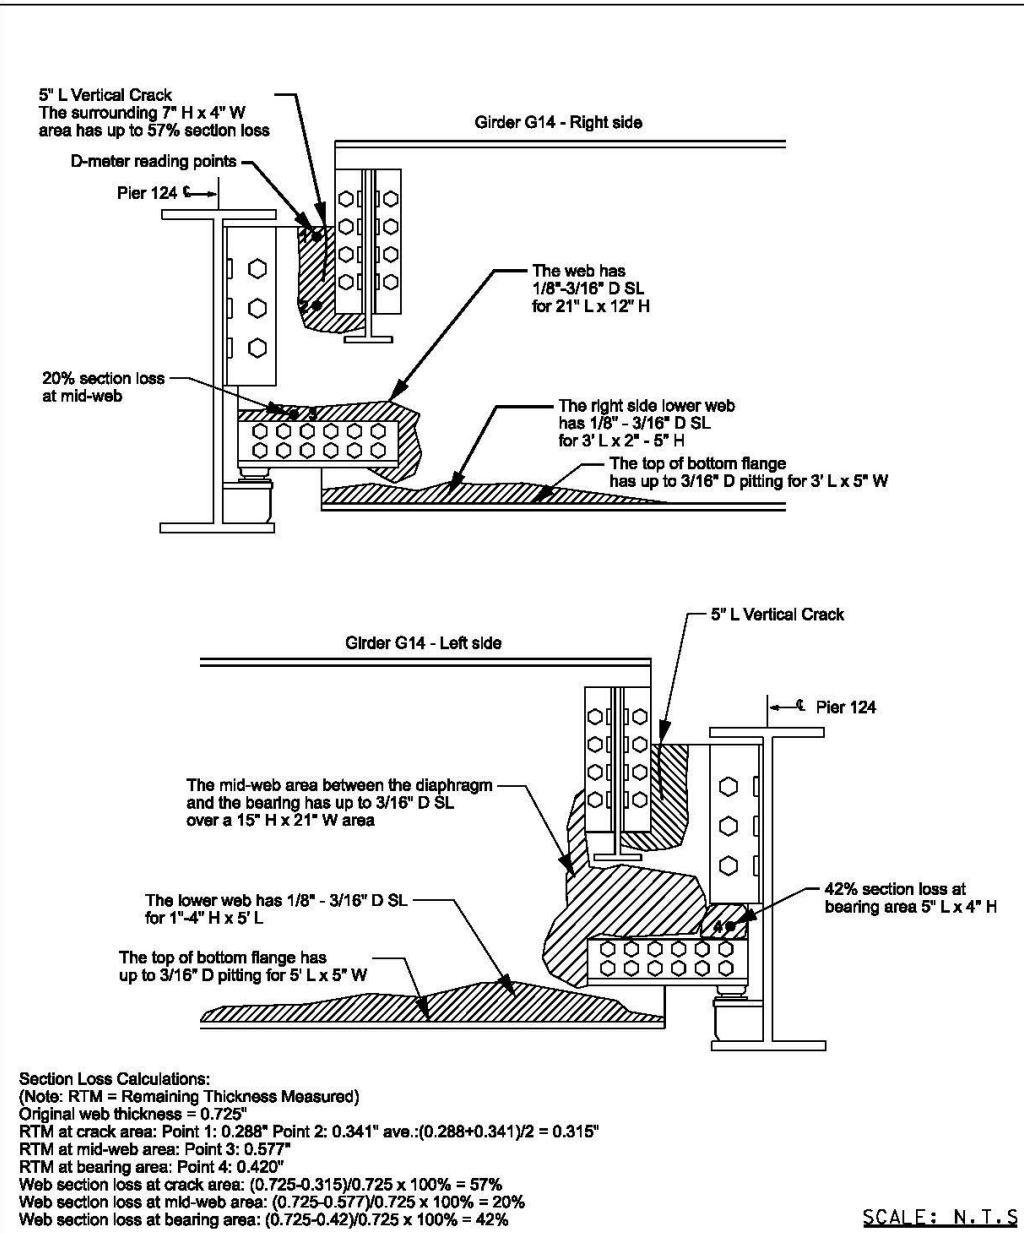
Photo Number: 2

Attachment Description: Sketch of defects at Girder G14, beam end at Pier 124, Span 125.

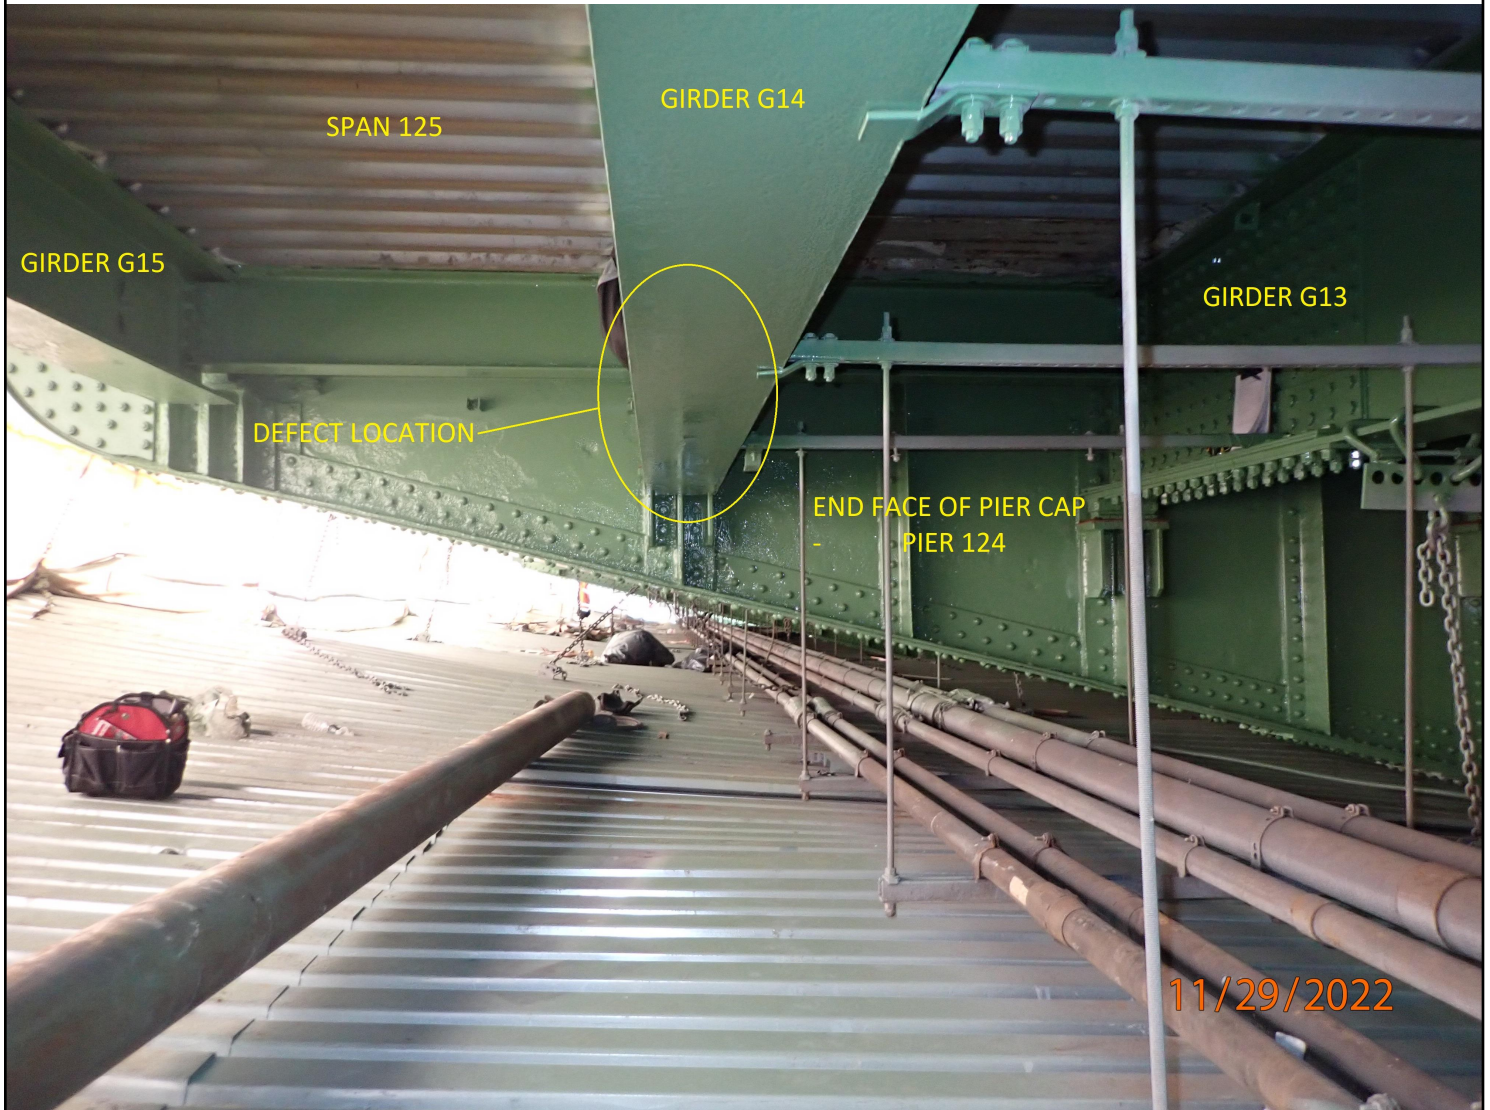
Photo Number: 3

Attachment Description: General view of location of flagged condition, G14 at Pier 124, Span 125. Looking begin.

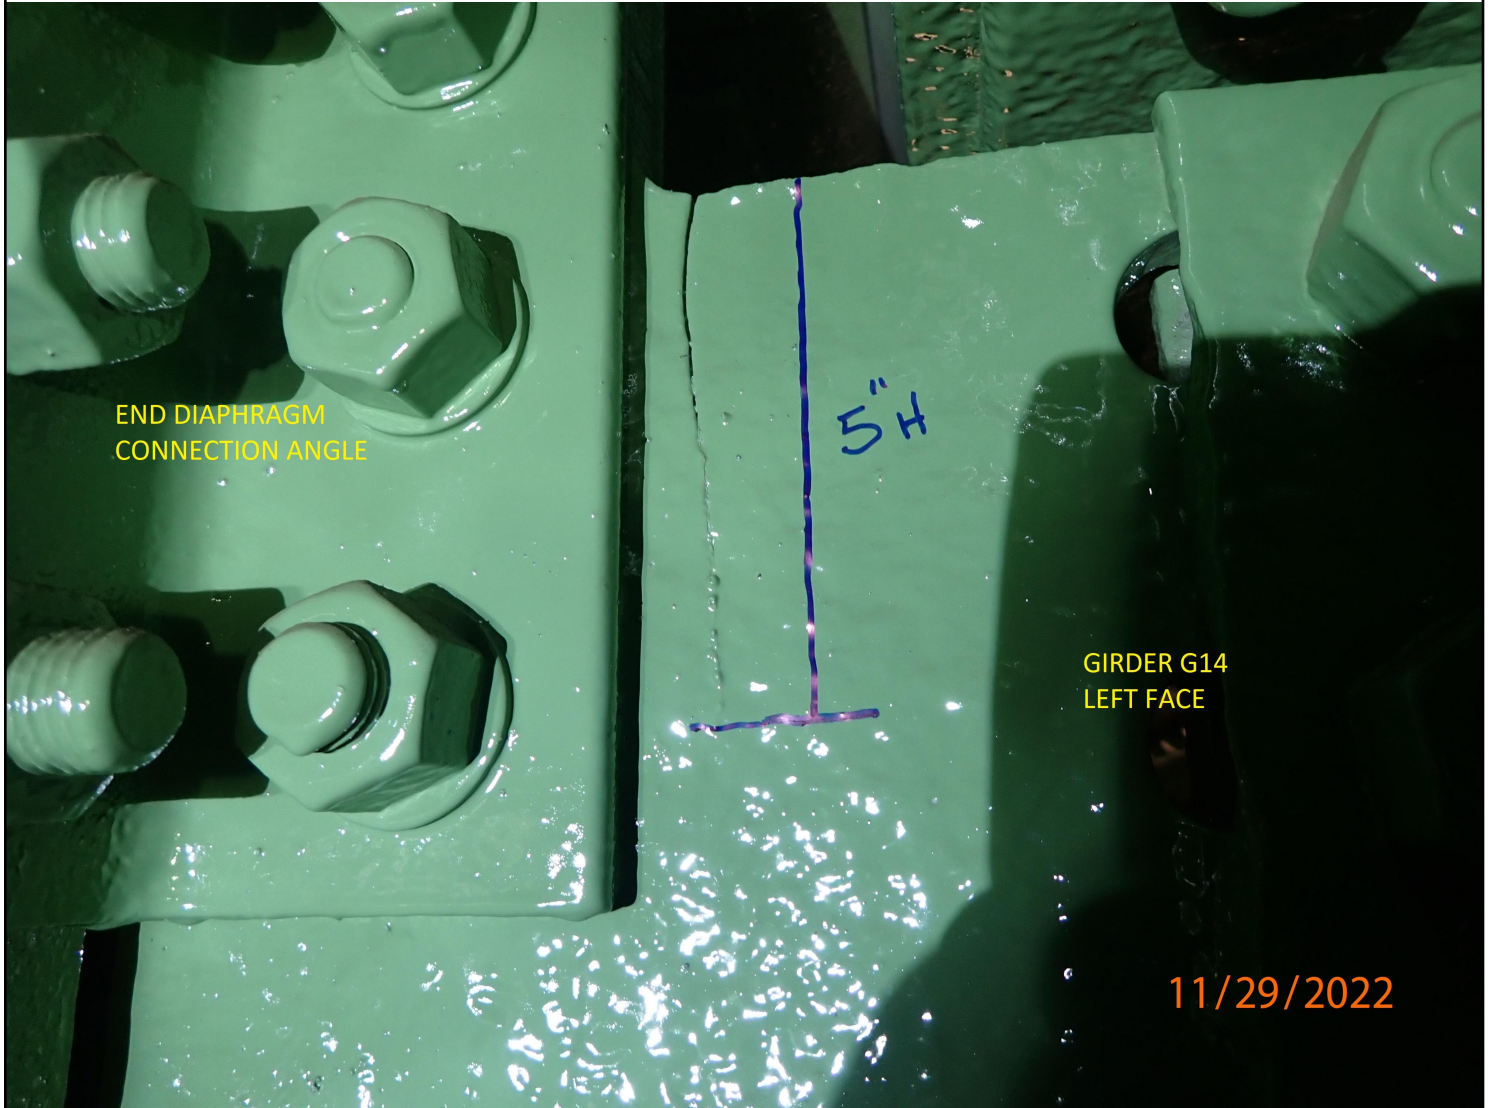
Photo Number: 4

Description: The end of Girder G14 in Span 125 at Pier 124 exhibits a 5" long vertical through crack in the upper web stemming from the top cope and extending downwards (Photos 4 & 5).

Attachment Description: Left side of web at the upper cope has a 5" L vertical crack adjacent to the diaphragm connection. The surrounding 7" H x 4" W area has up to 57% section loss. Looking right.

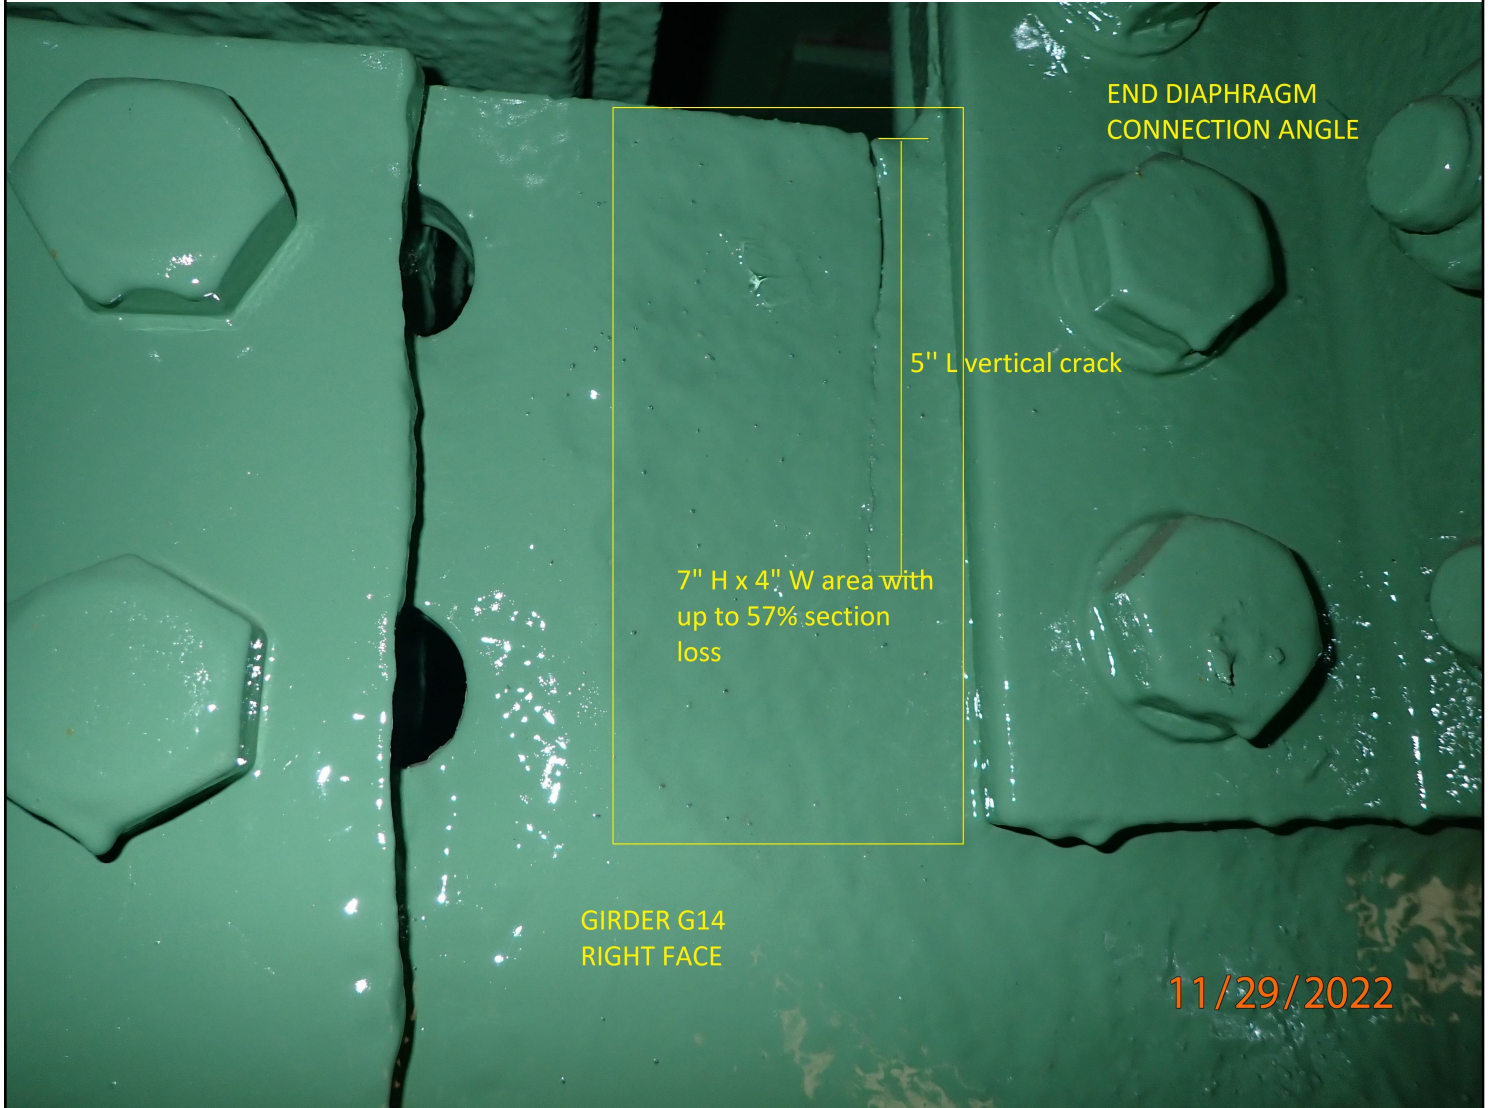
Photo Number: 5

The area surrounding the crack at the right side of the girder has up to 57% section loss over a 7" H x 4" W area based on D-meter readings (Photo 5). Adjacent to the horizontal stiffener angle at the left and right sides of the girder, the web has up to 20% section loss over a 15" H x 21" wide area (Photos 6 & 7). The web between the horizontal stiffener and the guide angle has up to 42% section loss over a 5" L x 4" H area. The lower section of the web at the right side has 1/8" to 3/16" deep section loss for 3' L x 2"- 5" H and up to 3/16" deep pitting at the top of the bottom flange for 3' L (Photo 8). The lower section of the web at the left side has 1/8" to 3/16" deep section loss for 5' L x 1"- 4" H and up to 3/16" deep pitting at the top of the bottom flange for 5' L (Photo 9). Refer to Flag Condition Sketch (Photo 2) for more details.

Attachment Description: Right side of web has a 5" L vertical crack. The surrounding 7" H x 4" W area has up to 57% section loss. Looking left.

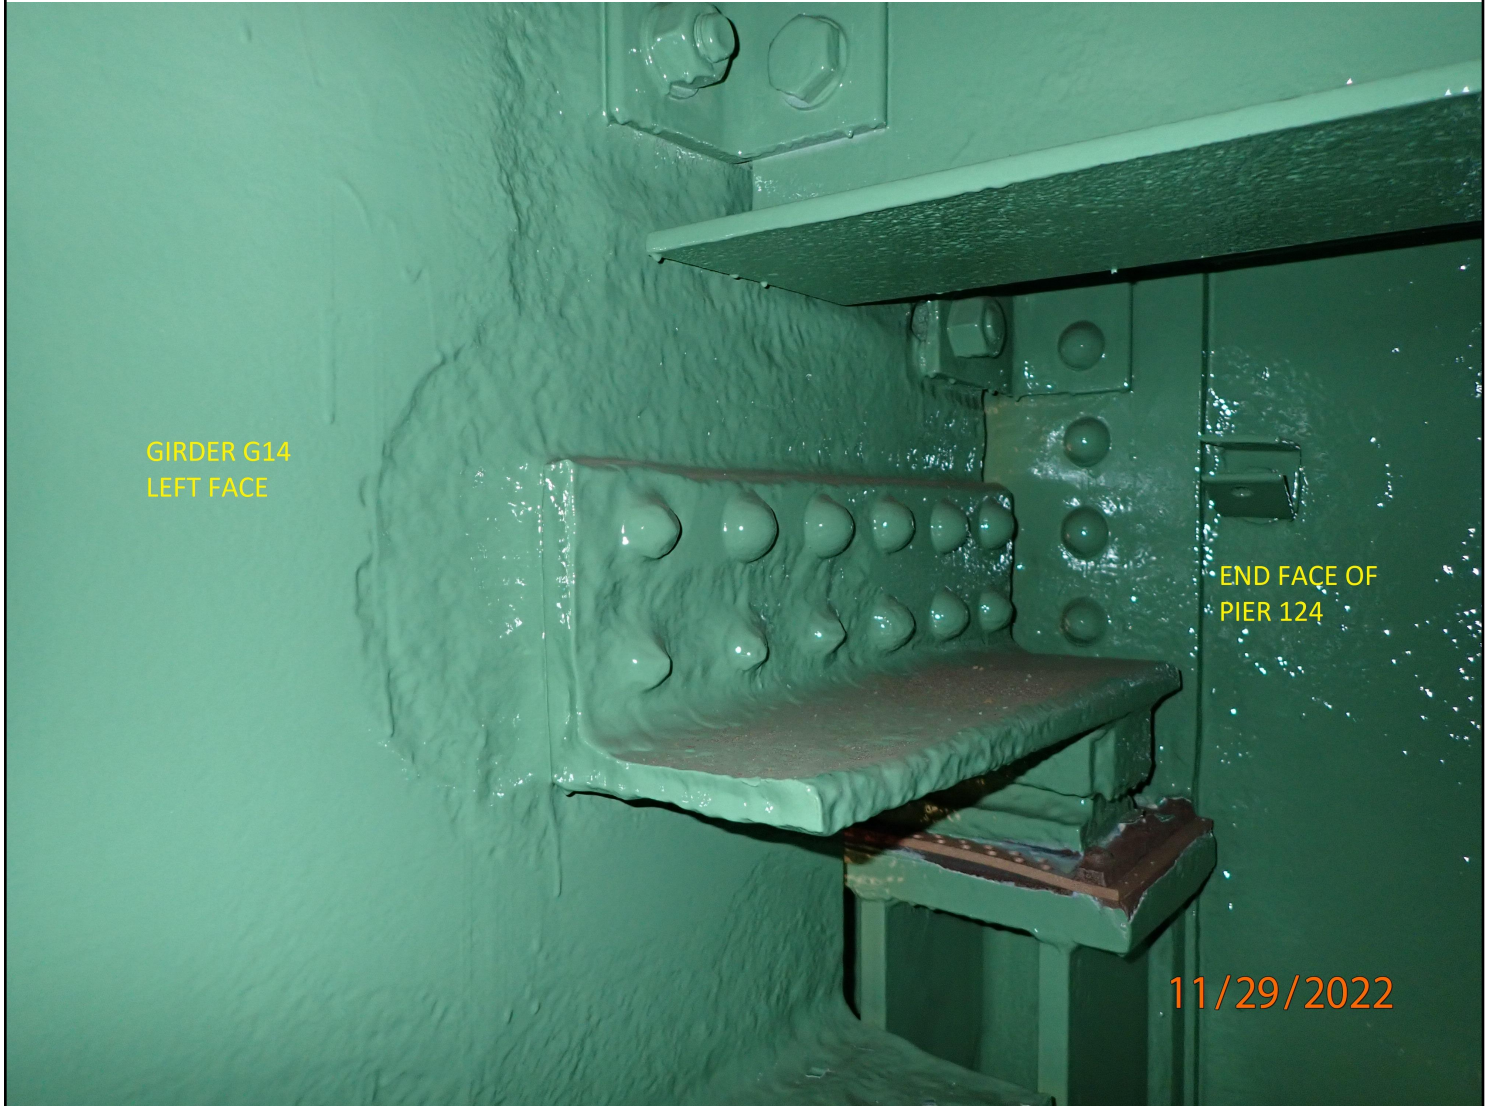
Photo Number: 6

Attachment Description: Left side of web at web stiffener angle has 1/8" - 3/16" deep section loss over a 15" H x 21" W area. Looking begin right.

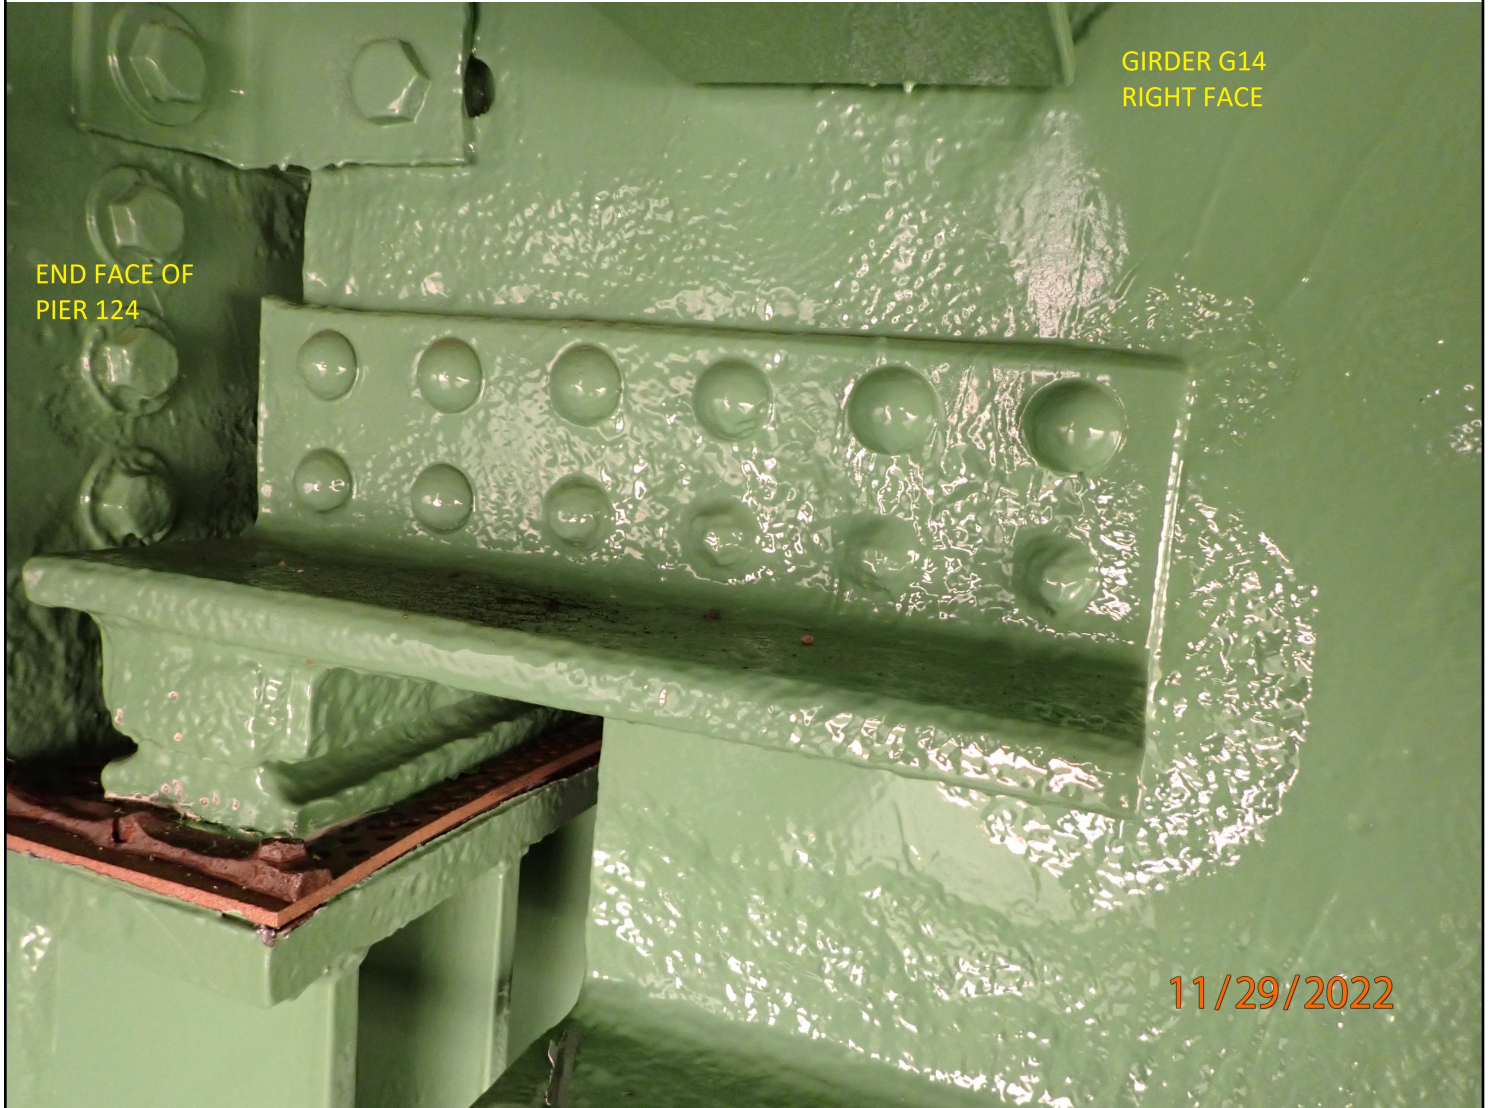
Photo Number: 8

Attachment Description: The right side of the web has up to 1/8" deep section loss in the area surrounding the stiffener angle. Looking begin left.

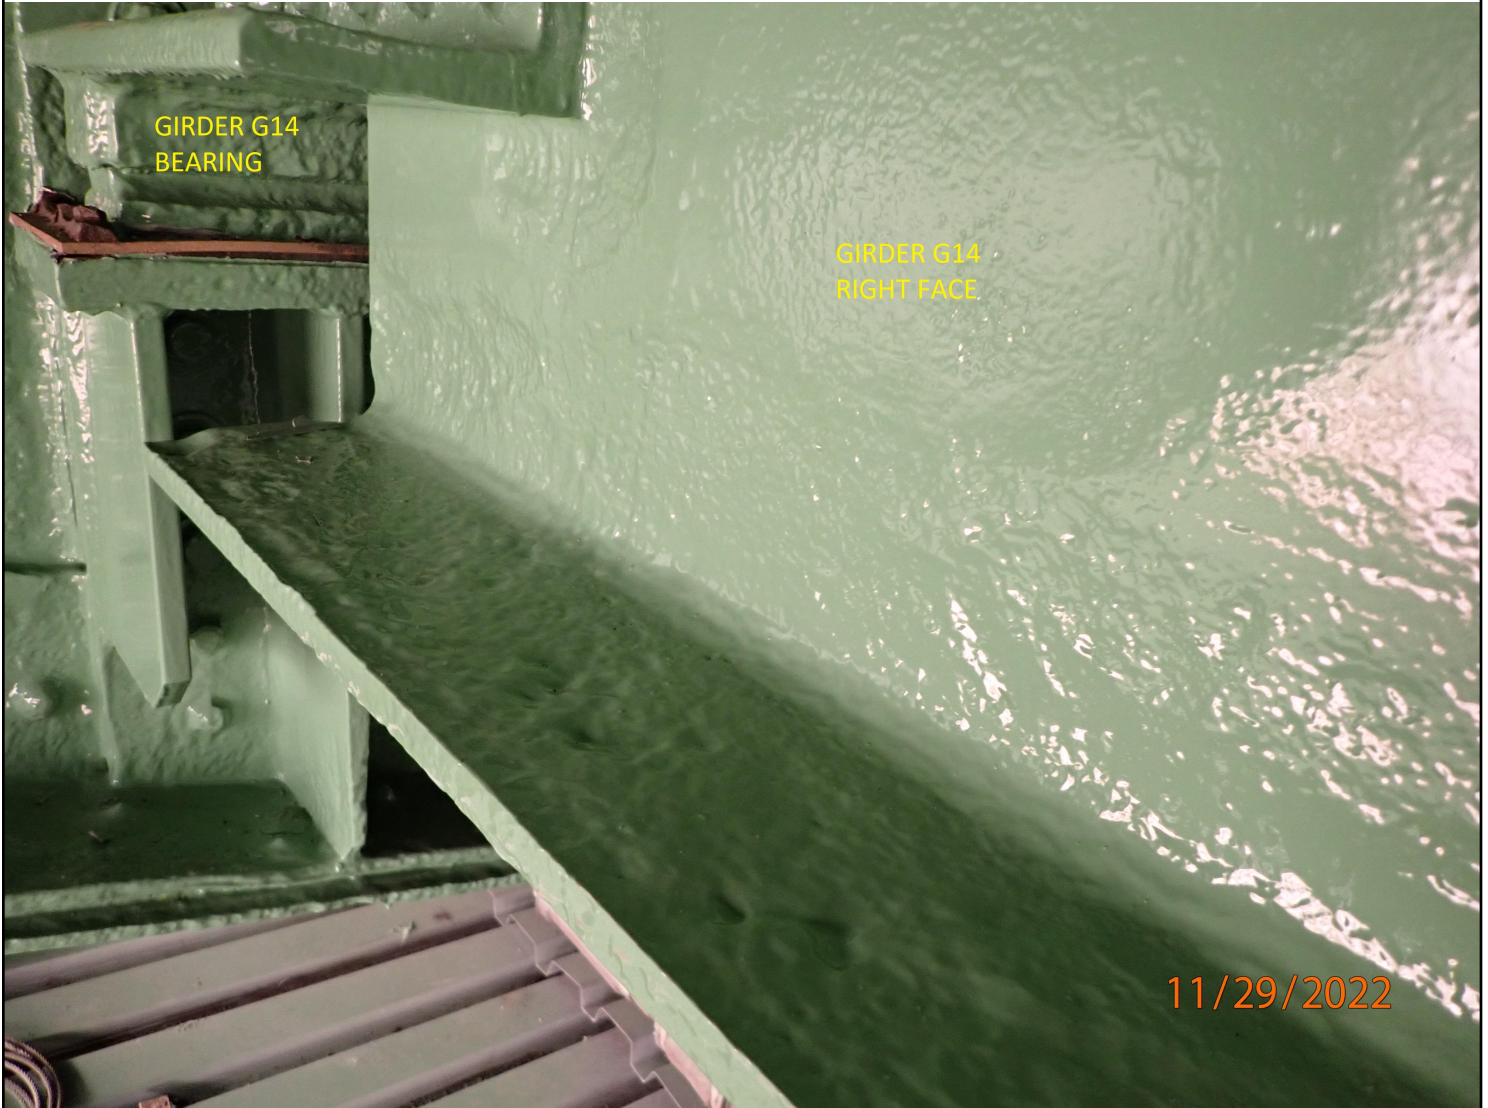
Photo Number: 9

Attachment Description: The lower web and top of bottom flange at right side has 1/8" - 3/16" deep section loss over a 3' L section. Looking begin left.
